## MULTIDISCIPLINARY APPROACH TO AN INVESTIGATION OF HAIL DAMAGED METAL ROOFS WITH A COSMETIC DAMAGE ENDORSEMENT

Hail claims involving metal roofs with cosmetic damage exclusions oftentimes require a multi-disciplinary approach to determine if a roof has indeed been functionally damaged. This matter provided a valuable investigative template for ESi and its clients, as these types of claims are increasing in frequency and value.

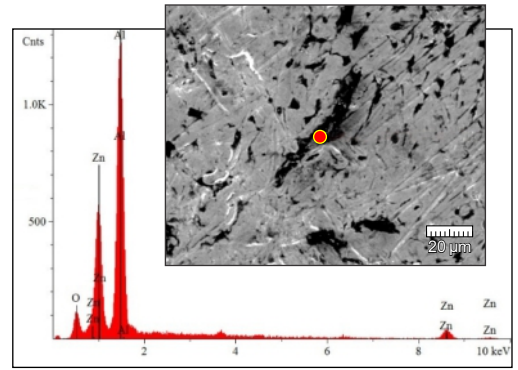
SEM-EDS (Scanning Electron Microscopy/Energy Dispersive Spectroscopy) analyses indicated that although the spray applied coating had deteriorated, the underlying Galvalume coating had not yet been exposed to the environment. No appreciable iron was observed in the EDS analyses of the surfaces, which shows that the underlying steel substrate beneath the Galvalume coating was not exposed to the environment and was not corroding.

Use of SEM with EDS to verify Galvalume<sup>®</sup> coating is intact and undamaged within hail dented area (No iron detected by EDS)

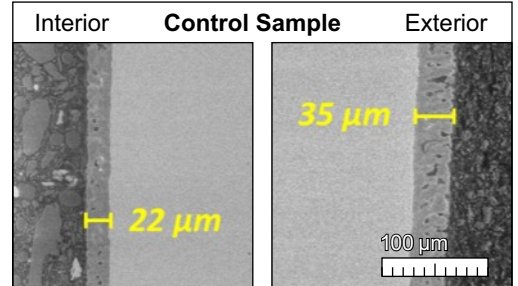
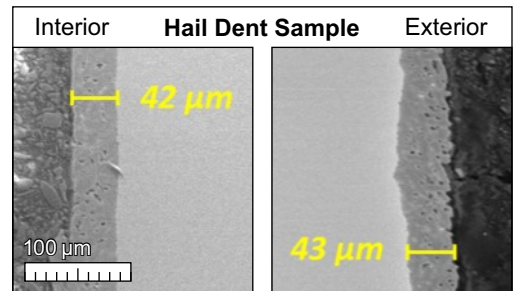
The roof samples were cross-sectioned, which allowed for measurements of the Galvalume coating thicknesses on the exterior surfaces of each sample. The analyses revealed that the steel substrate was protected by the coating on both sides of the samples. Specifically, the Galvalume coating on the exterior and interior surfaces of the samples was intact, and the thickness was similar between the hail dent samples and the respective control samples.

Measurements of the Galvalume coating thickness for the cross-sections prepared from a control and hail dent sample

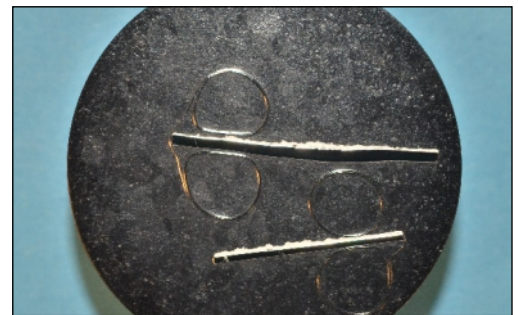
Metallographic mount containing cross-sections of the control and hail dent samples
